Monitoring Data Record

Project Title: R-2809B (Site 1) COE Action ID: 199601836  
Stream Name: UT to Richland Creek DWQ Numbers: 010550  
City, County and other Location Information: Wake Forest Bypass, Wake Co. (Left of Y2 Sta. 10+40 to Sta. 11+25)  
Date Construction Completed: April 2006 Monitoring Quarter: ( 2 ) of 4  
Ecoregion: \_\_\_\_\_ 8 digit HUC unit: 03020201  
USGS Quad Name and Coordinates: \_\_\_\_\_

# Wake Forest Bypass

2nd Quarter – August 2006

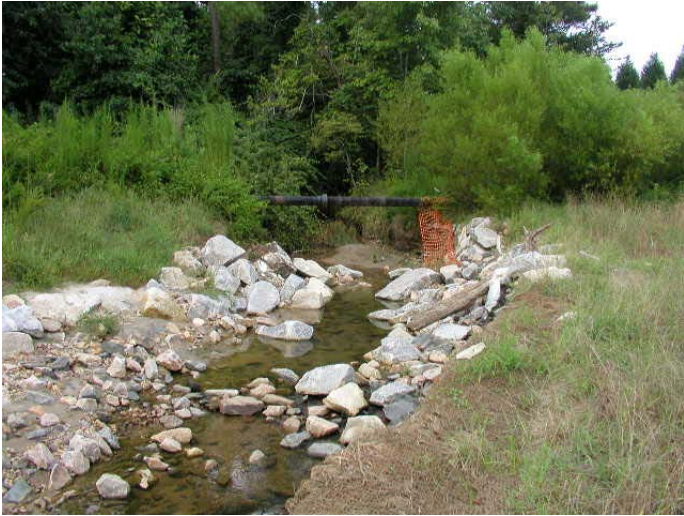
Photo 1 (Upstream)

Date Inspected	Station Number	Station Number	Station Number	Station Number	Station Number
Structure Type	Photo 1	Photo 3	Photo 5	Photo 6	
Is water piping through or around structure?			Water piping around left arm of cross vane		
Head cut or down cut present?					
Bank or scour erosion present?	Erosion on left bank	Erosion on right bank	Erosion on right bank	Erosion on left bank	
Other problems noted?		Right arm of cross vane has some slight erosion	Right and left arms of cross vane have eroded	Erosion behind left arm of cross vane
